RCRA FACILITY ASSESSMENT

Trent Tube Division
Crucible Materials Corporation
2100 East Orangethorpe Avenue
Fullerton, California 92634
EPA I.D. #CAD008325110

California Environmental Protection Agency
Department of Toxic Substances Control
Standardized Permits and Corrective Action Branch
700 Heinz Avenue, Suite 300
Berkeley, California 94710

May 2000

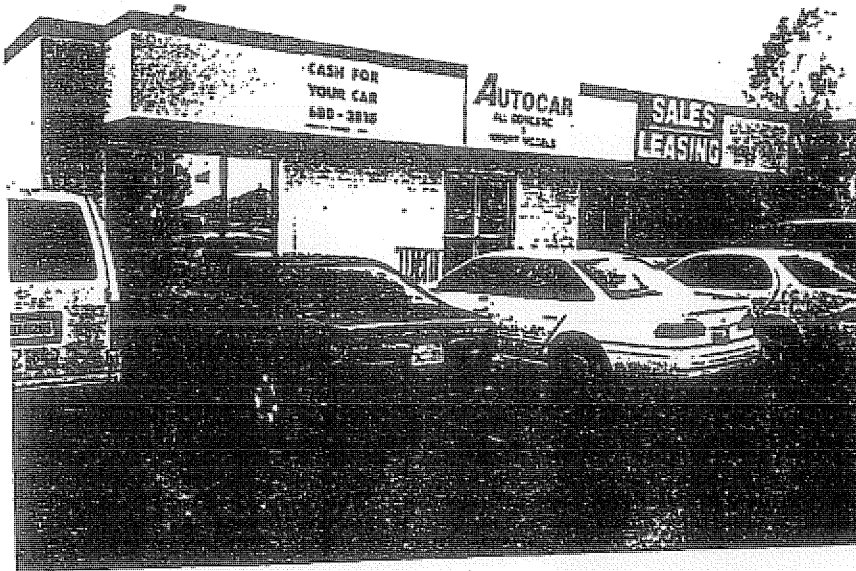
Photo #1 - front of building, former office for Trent Tube

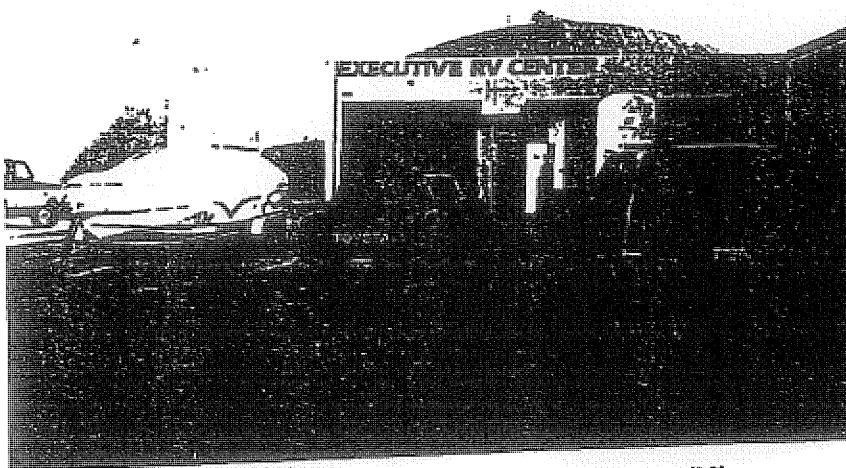
Photo #2 - east side of office, entrance to main building

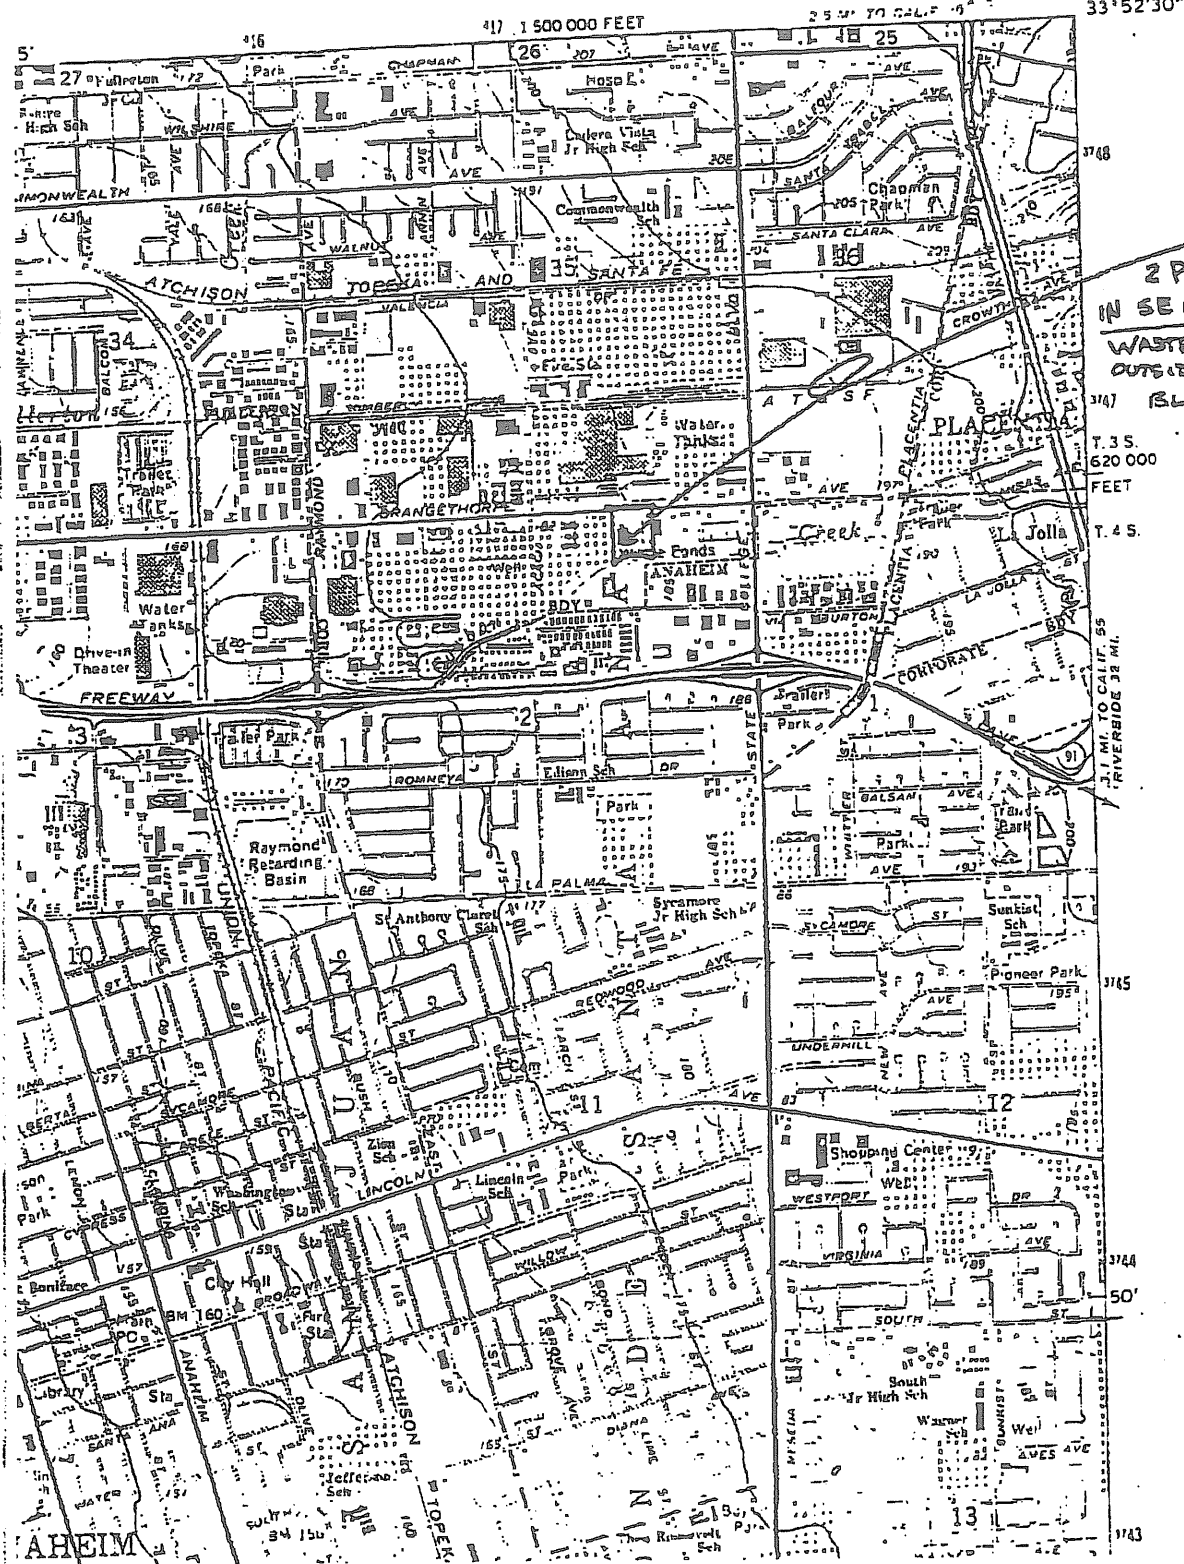
2 PICKLE TANK
IN SE CORNER
WASTE OIL CONT
OUTSIDE SW COR
BLDG

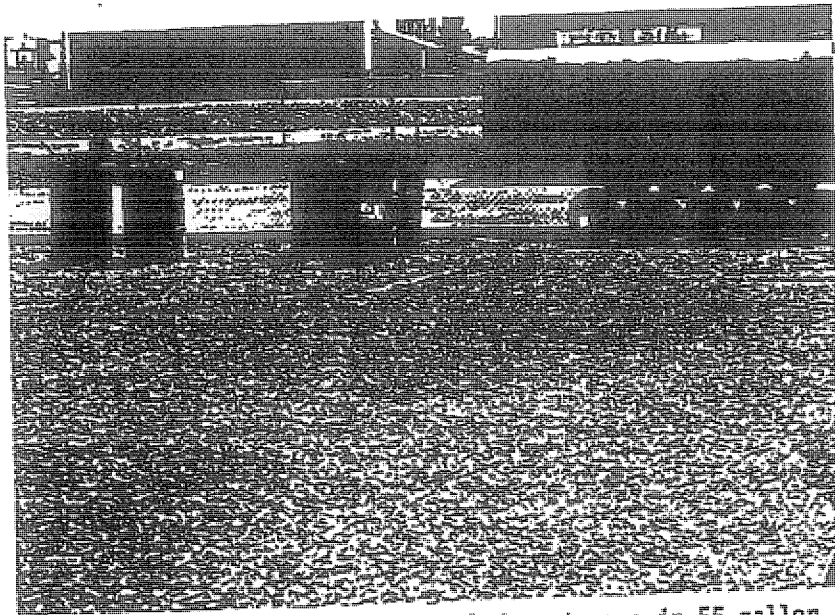
Figure 3 - Waste degreaser still sludge storage in 55 gallon drums at southern edge of property. Upright drums contain waste. Stacked drums are empty. This material is sold for reclamation. Tank in upper right is on adjacent property and does not belong to Trent Tube.

Drum Storage Areas (SWMU #1) and Area to the Rear of Facility (AOC #1): Since no confirmation sampling was performed after remediation of contaminated areas to the rear of the facility, it is recommended that a comprehensive soil-vapor sampling plan be developed and implemented in these areas. In addition, it is recommended that soils be sampled and analyzed for nickel, chrome, and lead. Soil must be characterized to a sufficient depth (from the surface to

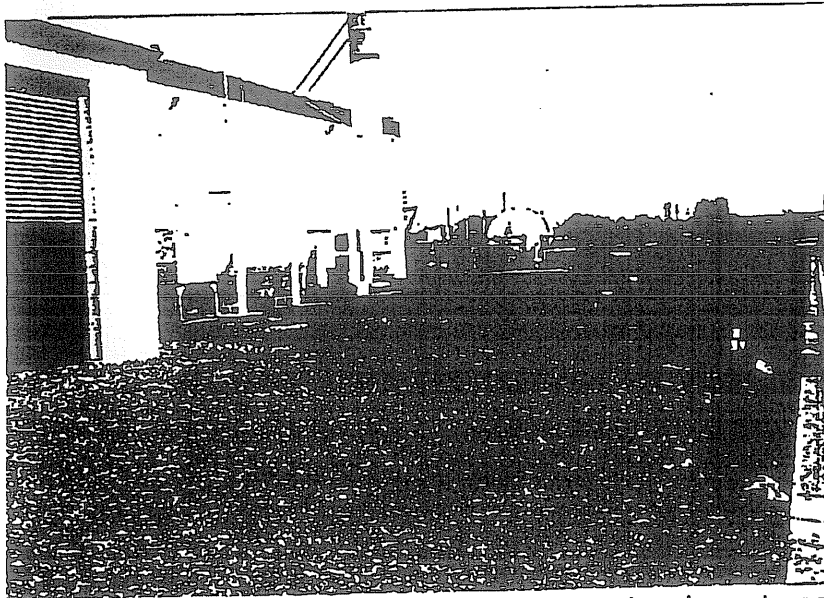
Figure 2 - Rear of plant (south end) also showing drum storage adjacent to curbing. Taken from south west corner of property looking east.
